Hail Damage – A 2019 Case Study and Lab Trials

James Rand, Chris Thompson, Mason Reed, AJ Hendricks, Andrew Cooper

Core Energy Works

This white paper summarizes a talk given by James Rand at the 2020 NREL Photovoltaic Reliability Workshop, 26 February 2020.

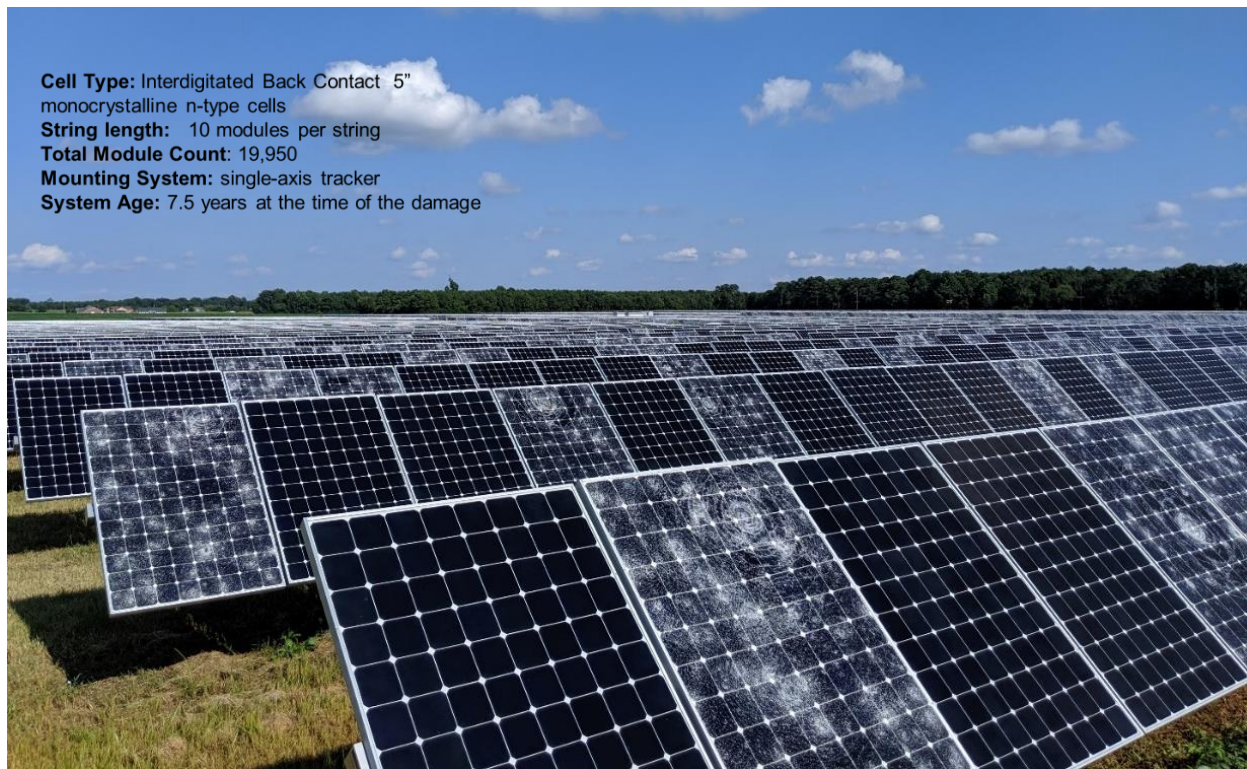
Figure 2: Photo of the hail damaged modules and site details.

Figure 2 and Figure 3 show that modules with broken glass were found spread throughout the array, interspaced with modules with intact glass. Some information on the storm can be extracted from the photographs taken of the damaged modules. The impact that initially broke the module was clearly identifiable and is typically the largest impact site. After the glass was broken, subsequent strikes disrupted the broken glass and left visible marks. Figure 3 shows the range of hail diameters estimated from the size of these secondary impact marks. Because the secondary impact marks are larger than the actual diameter of hail, a correction factor was calculated by firing hail balls with known diameter at a broken panel and measuring the resultant pattern in a laboratory environment. The average hail diameter was found to be 44mm (1.7") with a range of 26mm (1.0") to 56mm (2.2") for the small sample of panels evaluated. Social media reports suggest hail reached 75 mm in size (3").

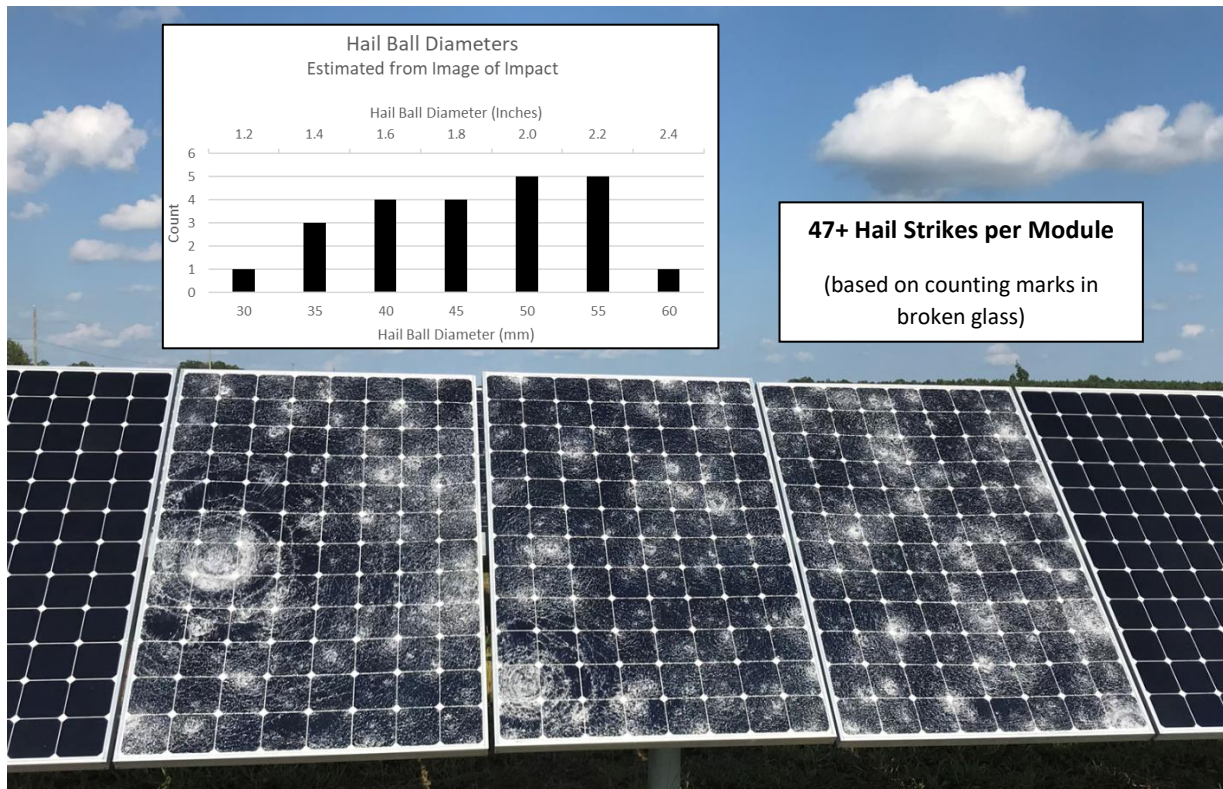
Figure 3: Estimating the hail ball size from the impact left on the broken glass.

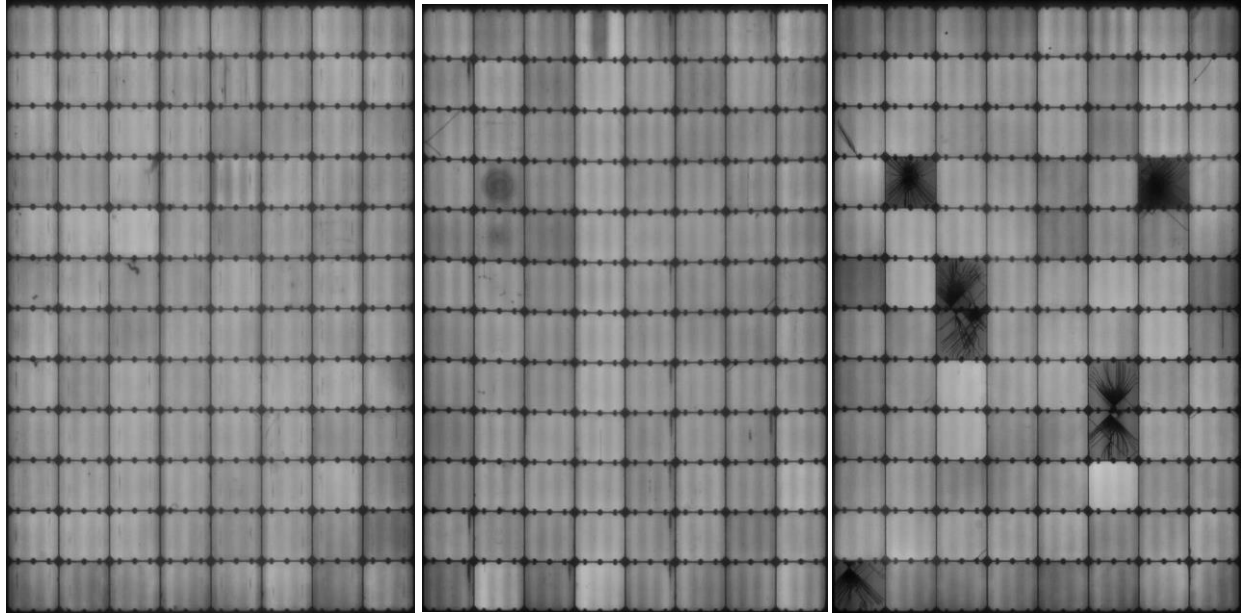
damaged due to the clear impact areas. Undamaged modules had little or no solar cell cracking as a result of the storm. Lightly damaged modules were defined as modules with some damage that could not be clearly attributed to storm damage; the cracked cells had no clear impact center or star patterned cracks and may have resulted from rough handling during packaging, transportation, and installation. Storm damaged modules could be identified through EL by the clear impact points and star patterned cracks. Examples EL images from all three types of modules are shown in Figure 4, below:

Figure 4: Example EL images taken on modules with unbroken glass: Undamaged (left; lightly damaged (center); storm damaged (right).. shows the distribution of the 301 EL samples between these three categories. Most module with intact glass were undamaged (61.5%). This is quite an impressive result given that they were hit with on the order of 50 hail balls as big as 60mm!

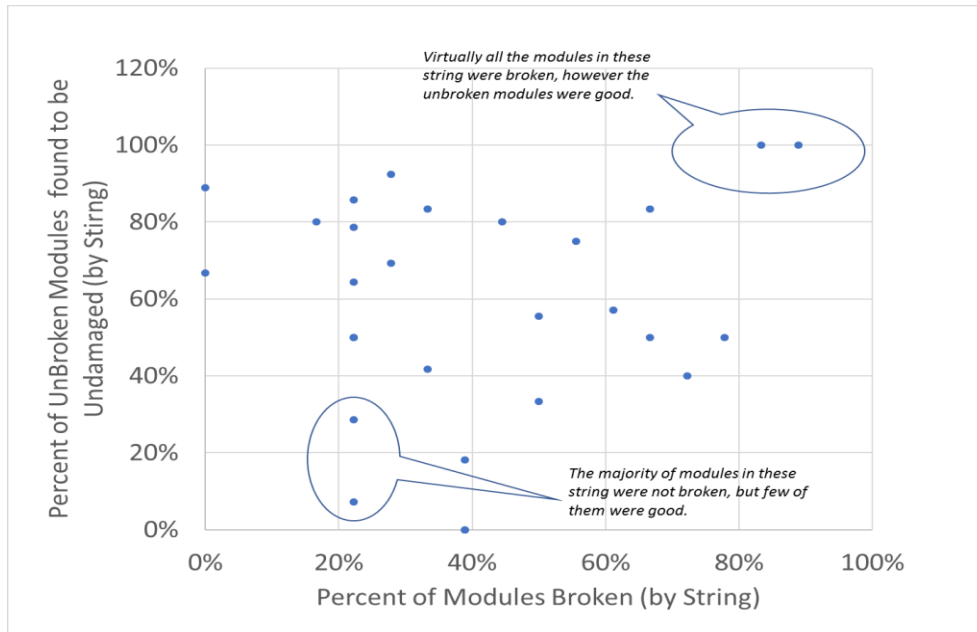
An analysis of the physical distribution of undamaged modules vs modules with broken glass across the site reveals no correlation between the density of modules with broken glass and the probability that modules with unbroken glass in the same area will be undamaged (see Figure 5, below). In other words, you cannot conclude that regions with high glass breakage also have high levels of cell damage within the modules that do not have broken glass in the same area.

Figure 5: The percent of undamaged modules vs modules with broken glass for each of the strings tested. The data suggests that the percent of modules with broken glass is **not** a good indicator that modules in the same string are damaged.

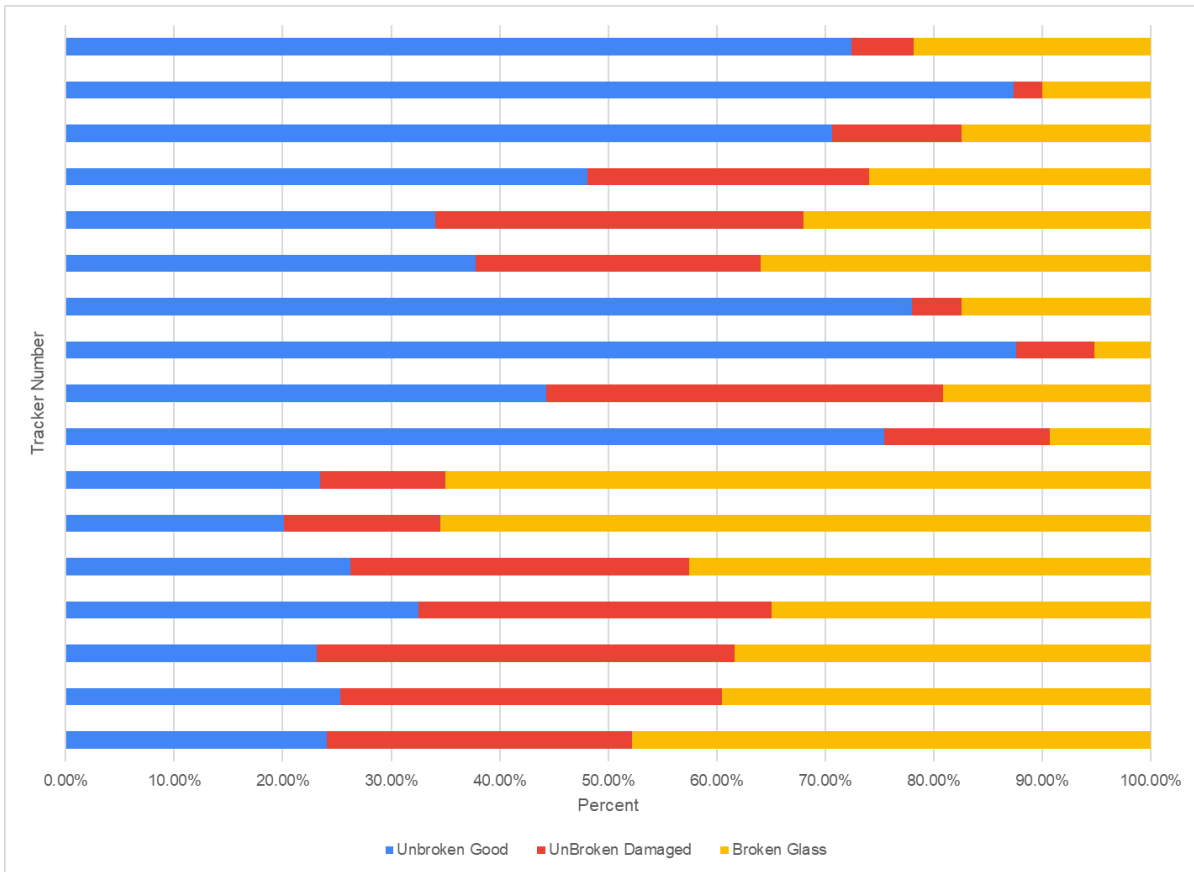
A follow up visit was conducted in which 100% of the 19,950 modules were counted as one of three categories: (1) broken glass; (2) unbroken good; (3) unbroken damaged. Figure 6, below, shows the results of the 100% inspection grouped by tracker number. Modules with broken glass are easily identified visually. However, visual inspection is not able to distinguish between a storm damaged and undamaged module when the module glass is unbroken. An alternative inspection method is needed as discussed in the next section.

Figure 6: Classification of 100% of modules at the site as “unbroken good”; “Unbroken damaged”; or “Broken glass” and grouped by tracker number. The data shows a range of damage from as little as 13% damaged to as much as 80% storm damaged. There are approximately 1000 modules in each tracker section.

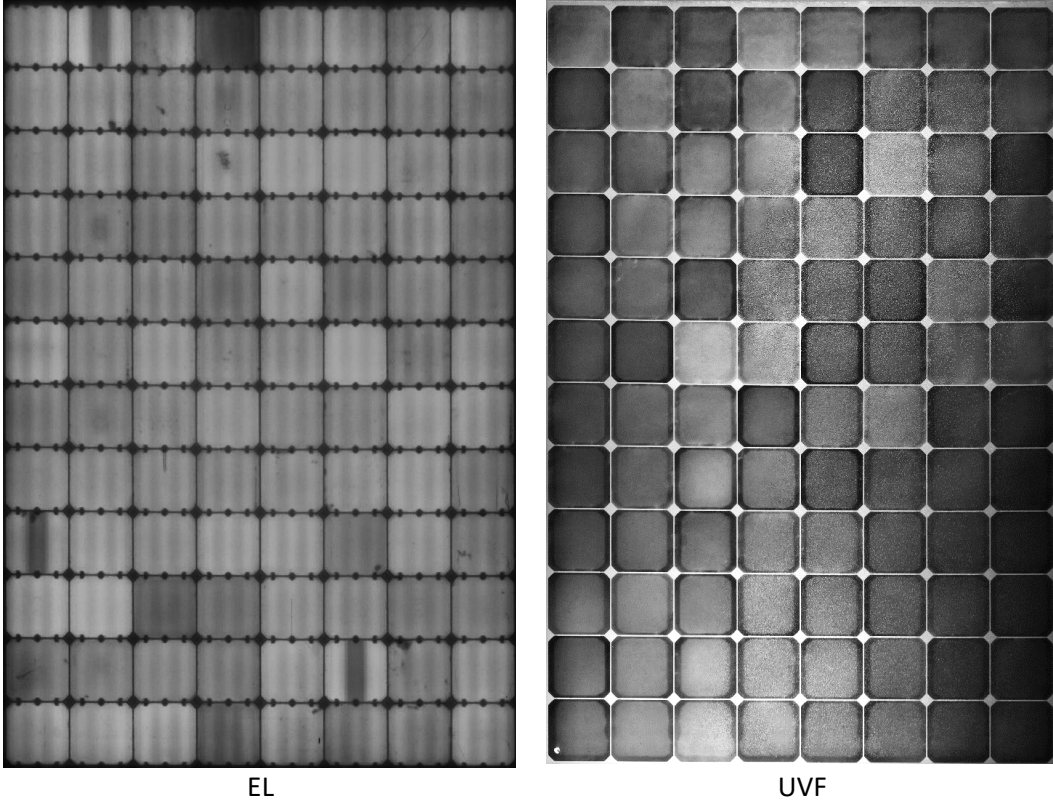
Figure 7: EL (left) and UVF(right) of the same un-damaged module. Please note that UVF is not sensitive to variations in EL due to electrical factors.

Figure 7 and Figure 8 above show EL and UVF images of undamaged and storm damaged modules. The UVF clearly reveals every cracked cell, and the pattern of the cracked cells. UVF measurements are contactless and rapid. The storm damaged modules with intact glass were identified rapidly and at low cost without dismounting or disconnecting the modules.

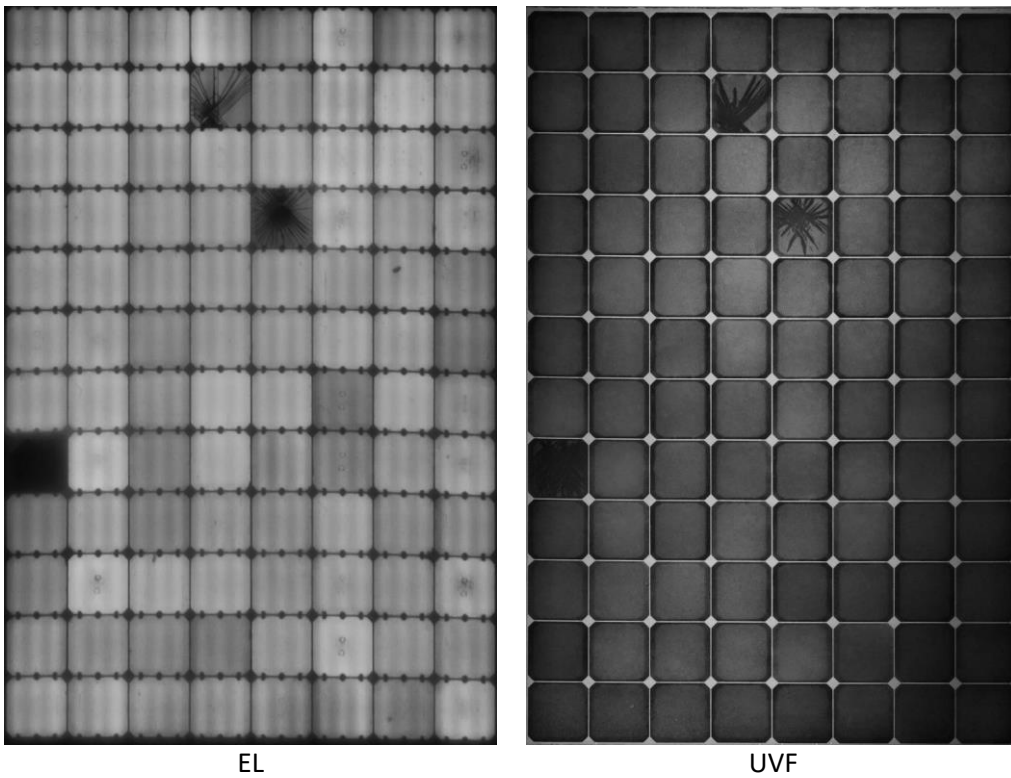
Figure 8: EL(left) and UVF(right) of storm damaged module, UVF clearly shows location and nature of cracked cells.

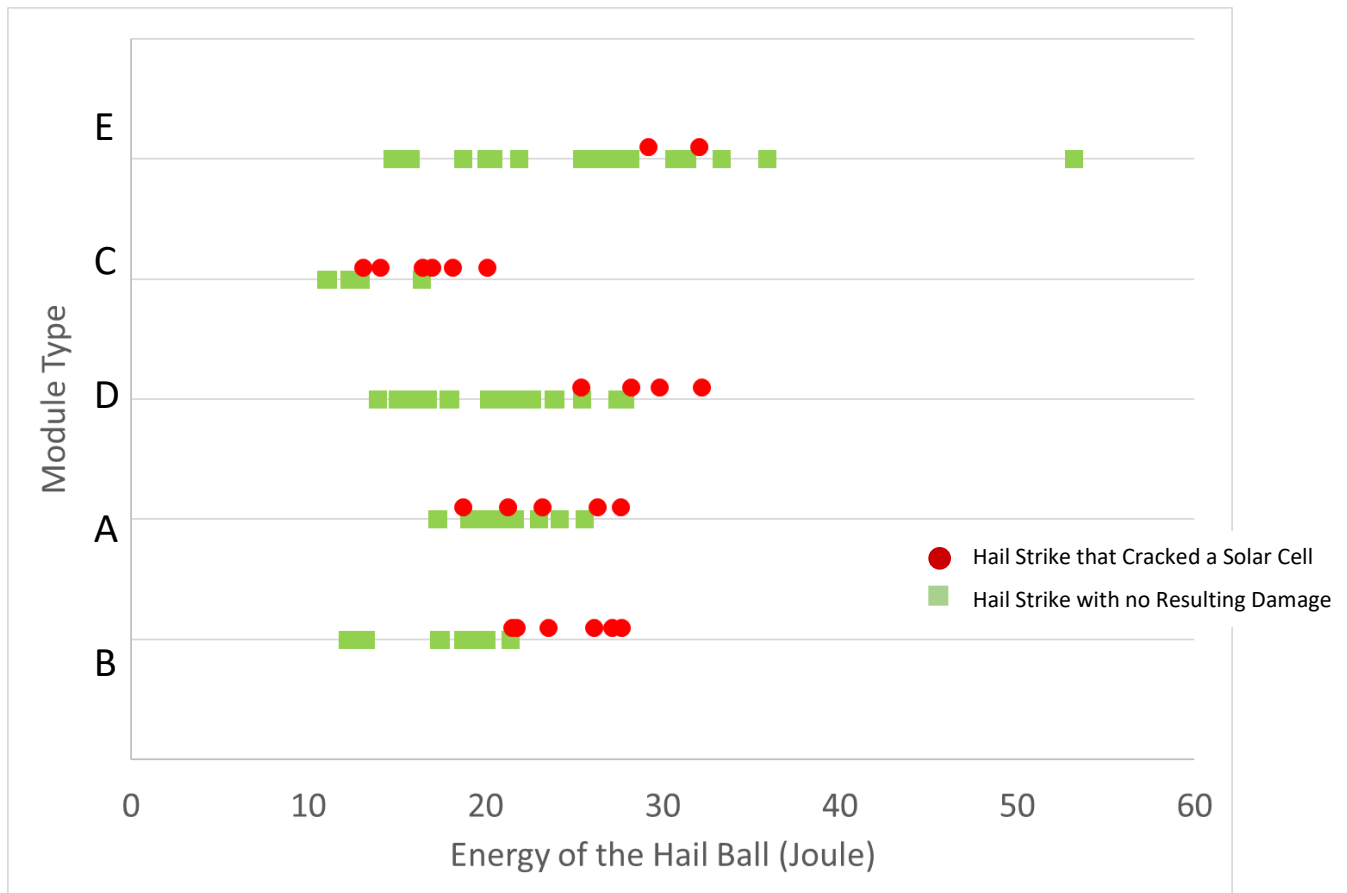
Figure 10: Hail damage threshold testing for five different module types.

In the Hail Threshold Test, modules were subjected to three hail strikes at a given kinetic energy and the energy incremented upward in 2.5J steps with a starting energy of 15J. IV and EL images were taken after each hail shot. If 2 out of 3 shots at a given energy level cracked a solar cell, the damage threshold was reached. Figure 10, above, shows the results for testing five different modules. Green marks indicate a strike caused no damage to the module and red marks indicated a broken/shattered solar cell. For module types E, D, & B, a clear threshold for damage is observed. For module type E no clear threshold was found, the shot energy increased until the module glass failed (i.e. the glass breakage energy threshold was lower than the threshold required to crack a cell for this module design). Please note that a broad or diffuse threshold energy for cell cracking is a likely indicator of a wide variation in pre-existing cell damage (i.e. critical crack length of brittle materials). Such examples may be certain types of half-cell modules where the process used to cleave the cell in two halves may have left micro-cracks of various sizes along the scribe.

The cell damage threshold ranged widely, from 12J to 30J. The equivalent hail diameter ranged from 1.6 inches to 2.24 inches, much greater than the required IEC 61215 minimum testing specification of 1". The IEC 61215 test does allow for hail impact testing over a range of hail diameter from 12.5 to 75 mm, however, 25 mm is the largest diameter required by the test.

Comparing these indoor results to the storm event discussed previously, where the hail had a median diameter of 1.8” and a maximum of 2.4”, almost all the panels represented in the study would have been heavily damaged. Only module type E would be predicted to survive in such a violent storm.

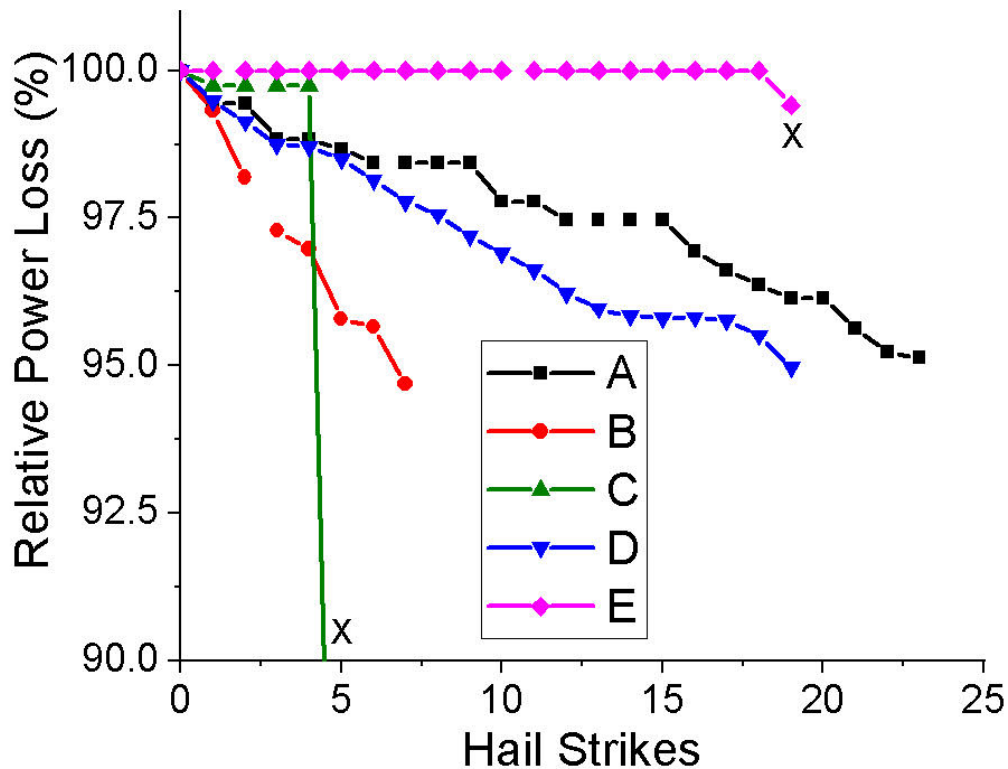
Figure 11: Relative power loss vs number of 30J hail strikes on 5 different modules types.

Figure 11 shows the relative power loss of each module vs the number of 30J hail strikes the module has endured. Modules were shot with consecutive hail balls until either maximum power (P_M) was reduced to 95% of the initial value or the glass failed, whichever came first. Two modules suffered glass failure, type C broke on the 5th shot and type E on the 19th shot. Modules found to have a relatively high cell damage threshold, as determined from the earlier testing, were not necessarily more tolerant to power loss due to that cell damage; type B, for example, lost 5% output power after only 7 hail shots. Other module designs were easily damaged (low cell thresholds) but had performance that was resilient in the face of that cell damage; module A, for example, withstood 25 shots and many cracked cells before failing 5% in power. These results indicate there is an interplay between cell damage threshold energy and cell interconnect topology that will determine the ultimate performance of that module after hailstorm damage. Of course, exposure to hail below the cell and glass breakage threshold is not

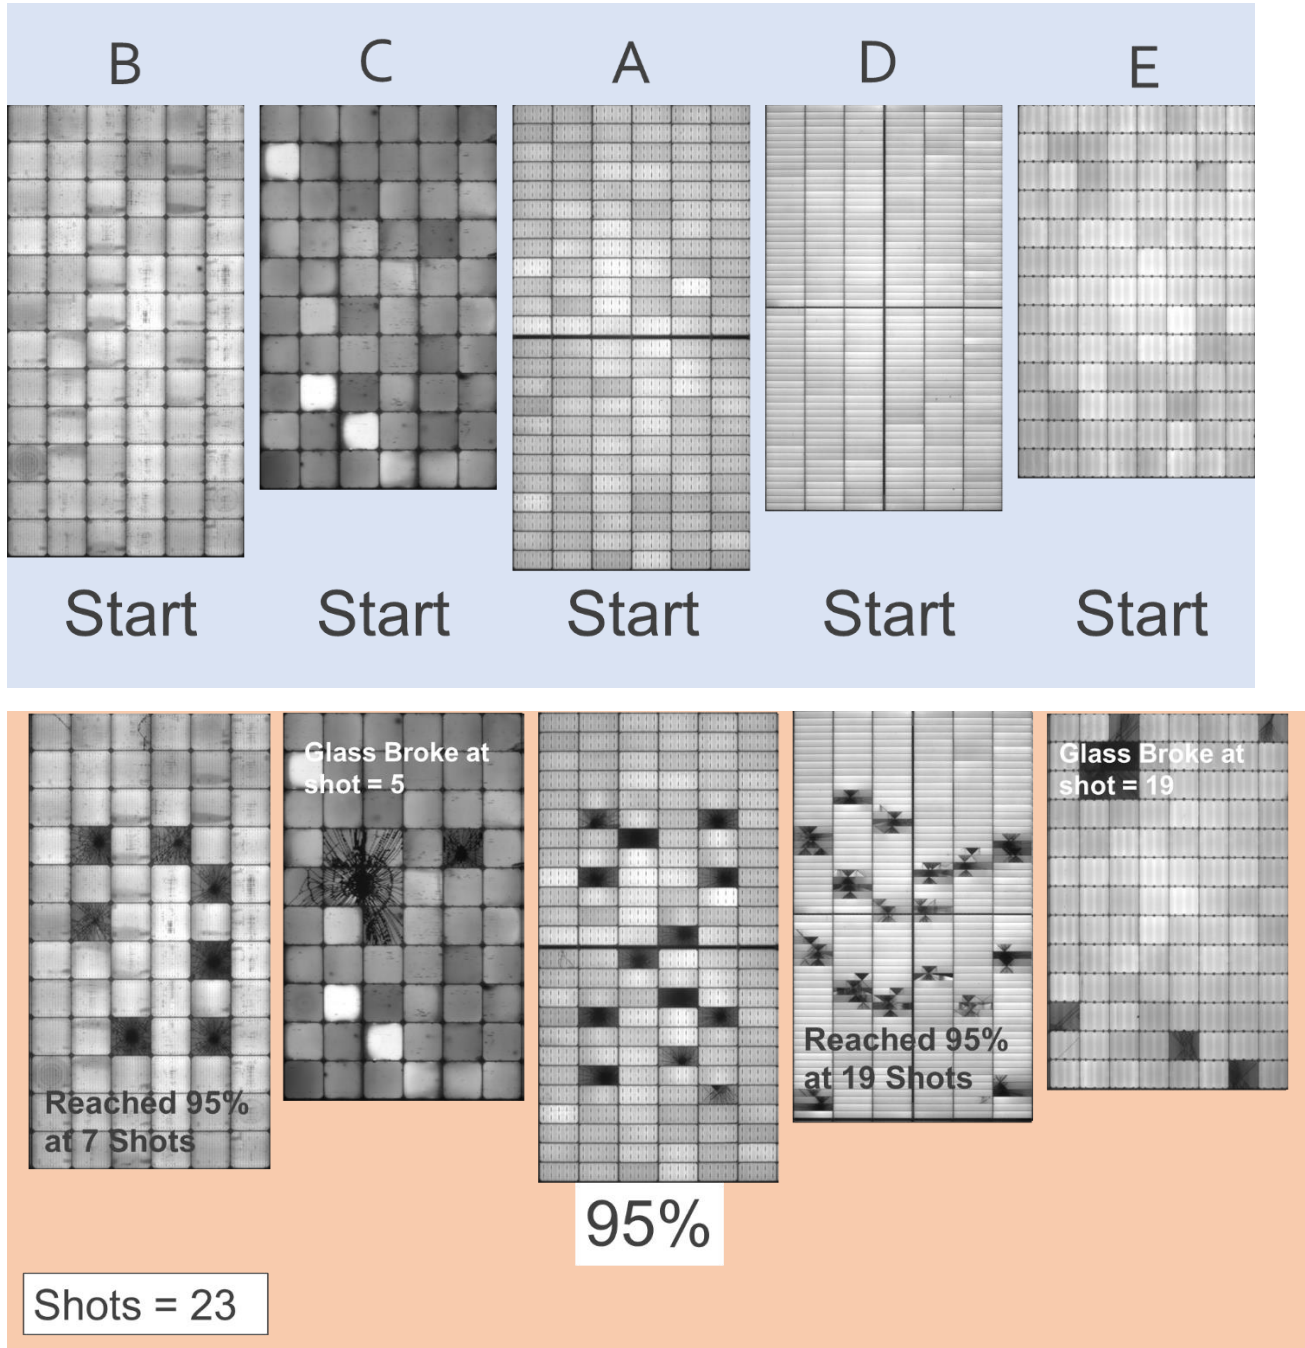
Figure 12 shows the initial and final EL image of each of the 5 modules tested. Note the end point of the test was different for each module, some breaking glass, others reaching the 5% degradation in power.

Figure 12. EL images of the five different modules tested. The top images are of the modules just prior to Hail Storm Stress Testing, and bottom image is after testing. The modules endured from as few as 5 shots to as many as 23 before reaching the end point of the test – either broken glass or a degradation of power to 95% of the starting point.
