# New Field Testing Protocol

*Monitoring DC Health*  
*February 2019*

# Core Energy Works' Experience with Field Testing Modules

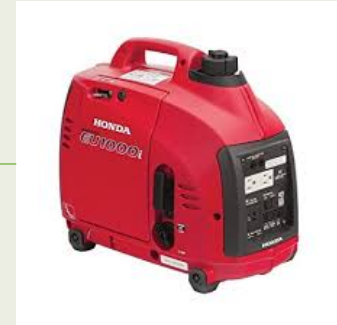
~1-2kW Ac Generator

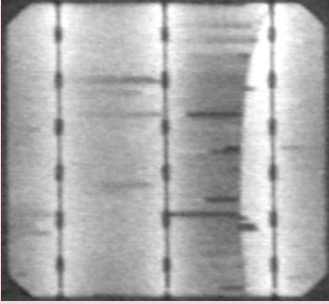
<p><b>Non-isolating crack</b></p>

<p>Interior cracks where all regions of the cell still have a direct path to a busbar are non-isolating and typically will not significantly degrade performance over time.</p>
<p><b>Isolation via multiple cracks</b></p>

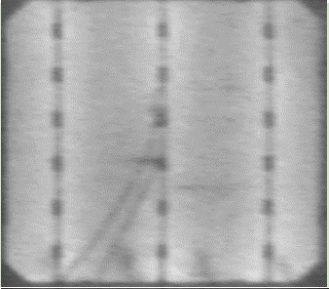
<p>Although not yet isolated in this example, multiple cracks are forming an interior region of the cell that can become isolated as thermal expansion/contraction stress continues</p>
<p><b>“Tire Track Pattern”</b></p>

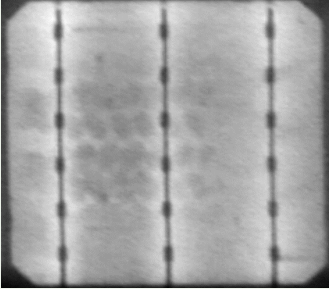
<p>This is a cell processing phenomenon occurring during the metallization firing step due to the belt pattern of the belt furnace “transferring” to the cell (probably due to a thermal shadow from the belt).</p>
<p><b>Degraded cell efficiency (LID or PID)</b></p>

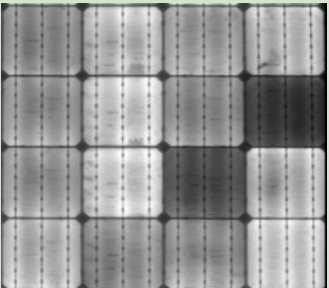
<p>The dim cells are less efficient. In this case, an exacerbated form of LID associated with p-type CZ cells is suspected, although PID is possible.</p>

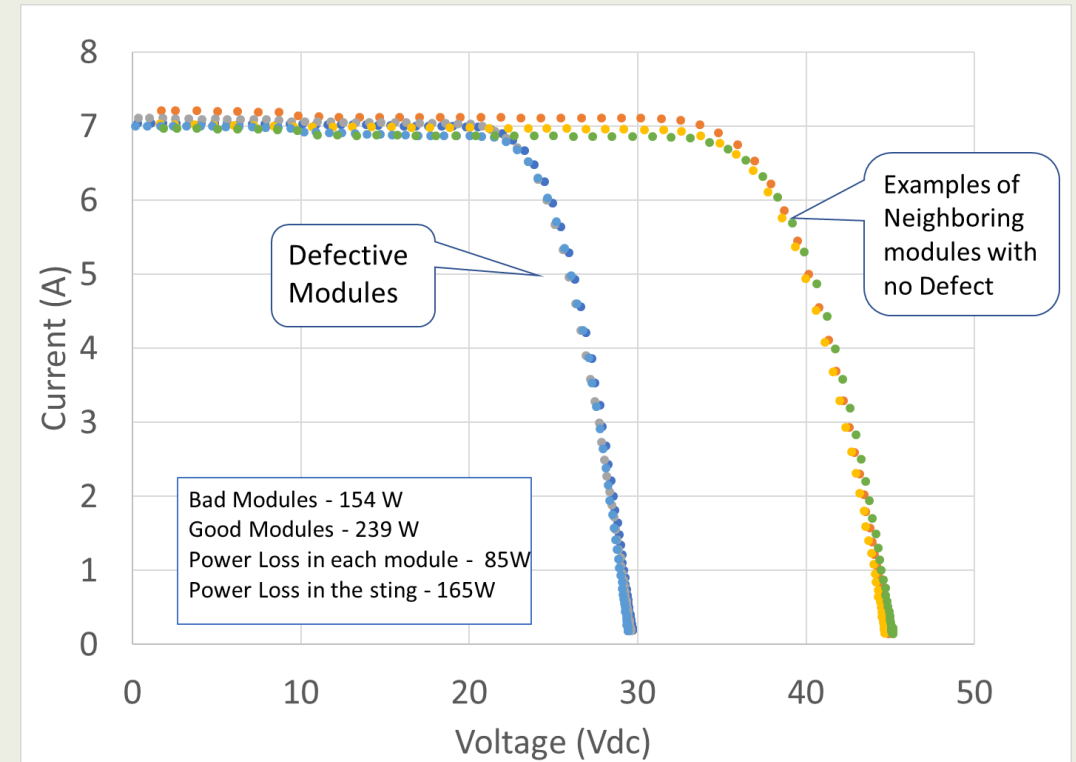
*The Tail of the Distribution has an Out Sized Impact to Overall System Performance*
