Hail Damage – A 2019 Case Study and Lab Trials

James Rand, Chris Thompson, Mason Reed, AJ Hendricks, Andrew Cooper

Core Energy Works

This white paper summarizes a talk given by James Rand at the 2020 NREL Photovoltaic Reliability Workshop, 26 February 2020.

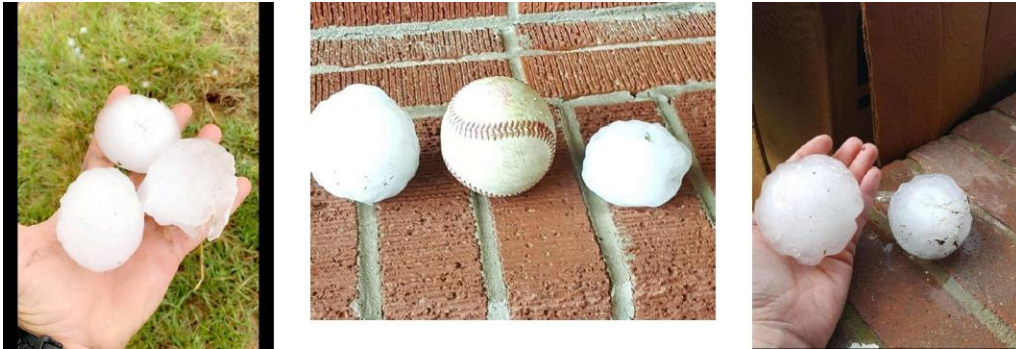
Figure 1: Photos of hail taken from social media from North Carolina hailstorm. For reference a baseball has a diameter of approximately 75mm (3"). "Baseball" size hail was reported in the local media as well¹. Other weather-related sites reported 70 mm (2.75") hail for this storm.

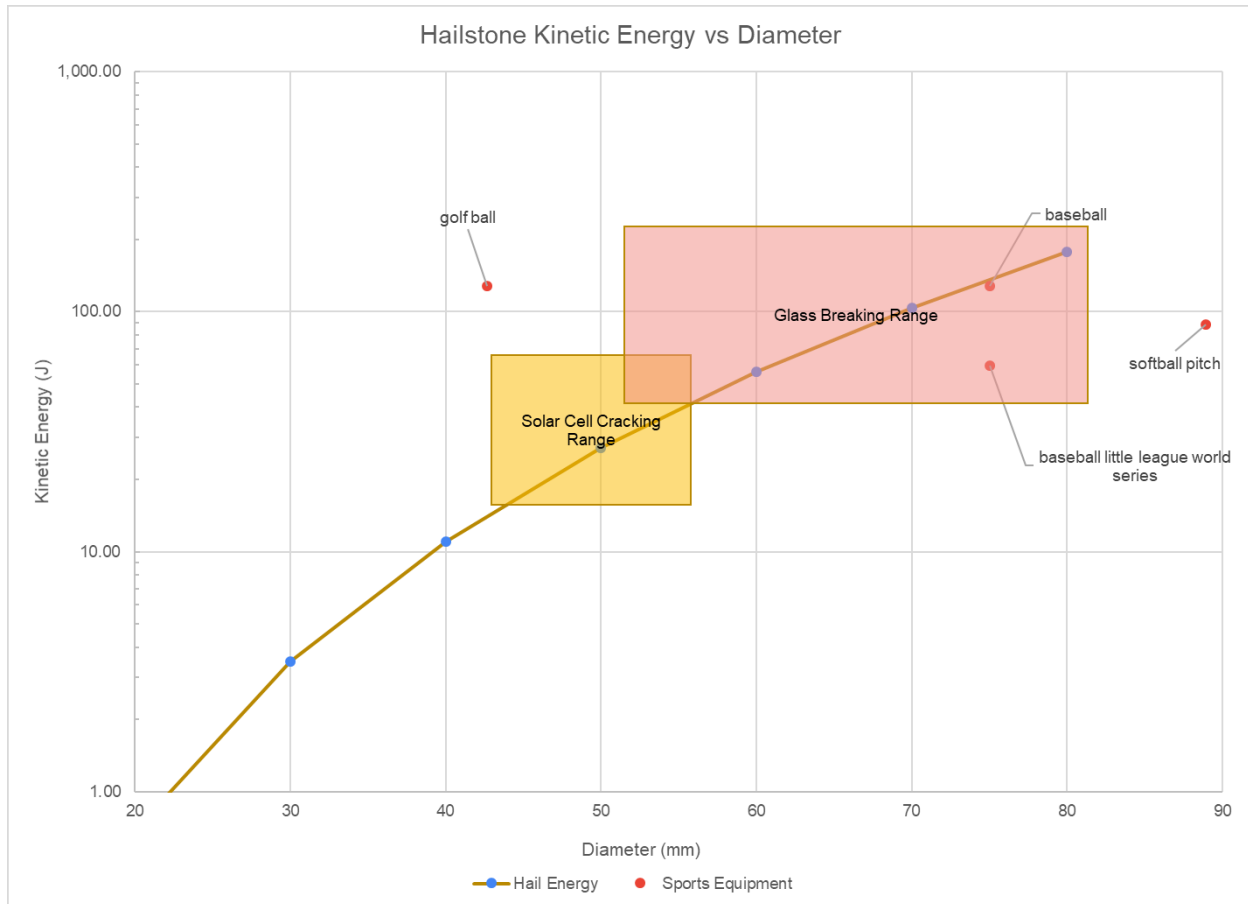
Figure 9: The natural behavior of hail ball in terms of energy (x axis) vs size (y axis) is shown based on calculating terminal velocity of a sphere. The range for solar cell cracking and glass failure are marked. Included for reference are a few common human launched spheres.

In the hail damage threshold test, increasingly energetic hail impacts were fired at modules under test to emulate the kinetic energy of larger and larger hail balls. The kinetic energy (E_k) of a projectile is given by $E_k(J) = \frac{1}{2}mv^2$, where m is the mass of the ice ball in grams and v is the velocity in m/s. The velocity is given by the equation for terminal velocity of a sphere⁴, where $v = \sqrt{\frac{4 \cdot \rho_{ice} \cdot d \cdot g}{3 \cdot \rho_{air} \cdot c_w}}$, where ρ_{ice} is the density of ice (870 kg/m³), ρ_{air} is the density of air (1.2 kg/m³), d is the diameter of hail, and c_w is the air drag coefficient, for a slightly rough sphere 0.5. The mass of a sphere of ice is given by $m = \frac{4 \cdot \pi \cdot (\frac{d}{2})^3}{3} \cdot \rho_{ice}$. Using all three equations, a plot of hail diameter vs energy at terminal velocity can be calculated (Figure 9).
